The Locomotive

THE HARTFORD STEAM BOILER
INSPECTION AND INSURANCE CO.

VOL. XL

1934-1935

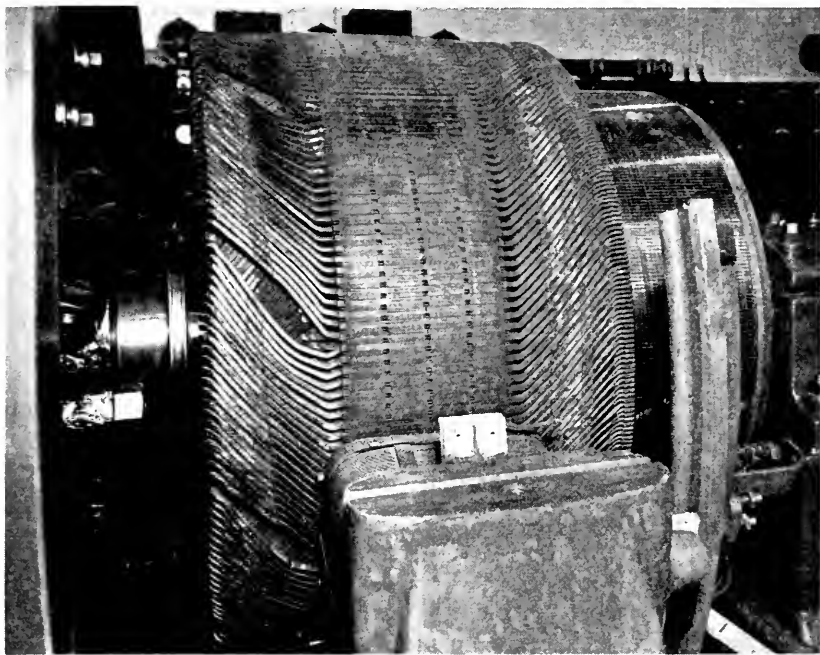
devices permitted the machine to continue on the line after the short circuit, thus causing the fire to spread and complete the destruction.

How widespread the loss was is illustrated by the photograph. The machine was so badly damaged that it was considered inexpedient to repair it.

When the fire was noticed in the rotary converter room, an effort was made to get to the switchboard on the other side of the rotary converter to stop the machine, but the heat was too intense. It was necessary to go to a penthouse on the roof to de-energize the feeder sup-

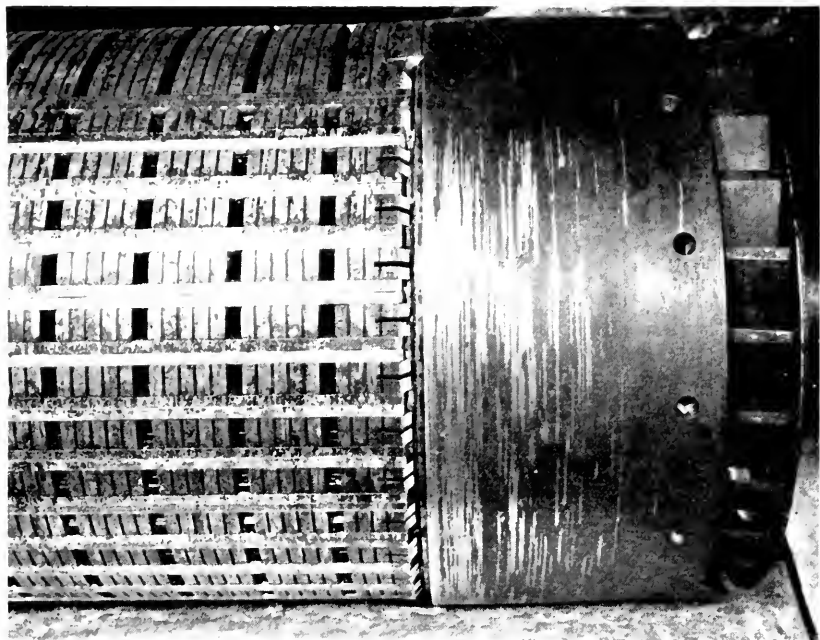
SIMULTANEOUS jamming of the throttle trip-valve and breaking of a pipe in the oil line serving the controls recently permitted over-speeding of a 3,000 kw turbine in a manufacturing plant and resulted in an accident that would have been even more serious had not attendants been in position to close the steam valves manually.

The machine had been dismantled for repairs and reassembled, the accident occurring during a test preparatory to putting the turbine back into service. Fortunately, the damage was confined to the wrecking of the generator. But for the fact that those present were able to act quickly to check the runaway, it is probable that the whole unit would have gone to pieces, wrecking the steam end and perhaps damaging surrounding property.

It was one of those accidents which cannot be anticipated, and it illustrates how, with every reasonable precaution taken by experienced operators, things may go wrong. The accompanying photograph of the generator rotor shows how near the unit came to flying apart.

Because they had found it difficult to keep old brass oil-pressure piping tight, the owners had substituted seamless steel tubing with welded joints except for three pieces of stainless steel piping, one of which was a $3\frac{3}{8}$ " nipple screwed into the cast iron primary oil relay cylinder of the governor. This nipple broke at the bottom of the thread at the point of entrance to the cylinder. Why it broke was not definitely decided, but it is believed possible that the nipple may have been cracked at the time the joint was assembled, the fracture becoming a definite break under vibration at a speed greater than normal, so that its failure coincided with the jamming of the throttle valve.

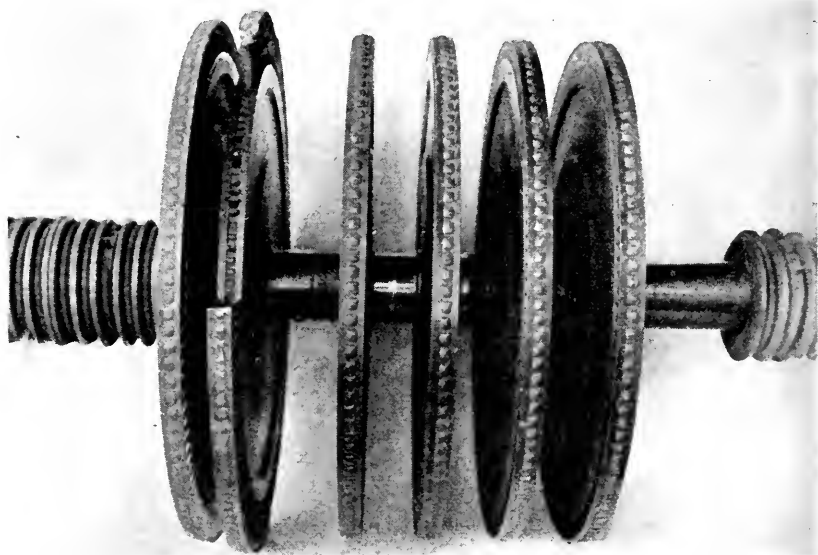
reached the tripping range (4,000 rpm on the hand tachometer) and the over-speed device on the shaft functioned, tripping the combination throttle and emergency stop valve, which, instead of closing, jammed in a partially-open position because of a chip of foreign material which had scored the guide. Incidentally, the erector had tested this trip valve by hand before bringing the unit to speed and it had closed satisfactorily. The erector heard the over-speed device operate, but as the turbine

Damaged rotating field after over-speed. The core is a solid steel forging so machined that the forged steel end rings are fitted into a rabbet-joint on the ends of the rotor forging. The centrifugal forces exerted against this rabbet were sufficient to break off sections of the steel rotor forging, which immediately jammed between the field and stator where they were rolled into small balls or were embedded in the stator laminations.

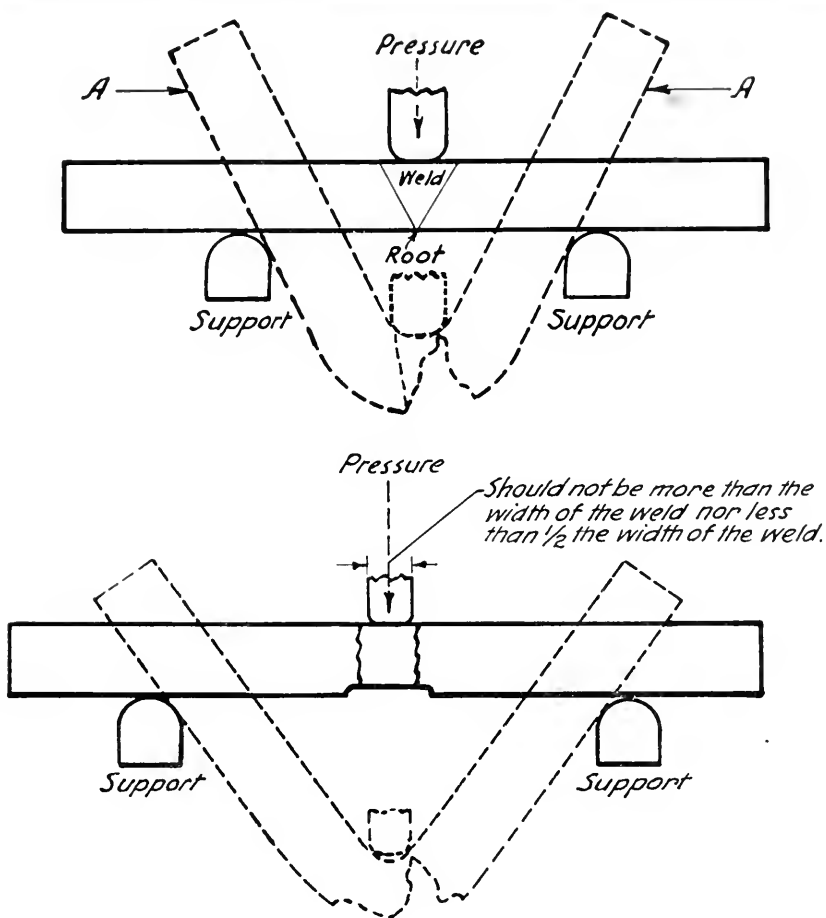
Figure 6 (Top). Figure 7 (Bottom).

The methods for testing the tensile, free bend, and nick break specimens have been in general use for several years and need no comment here. The methods of testing the root break and side break specimens are shown in Figures 6 and 7 respectively.

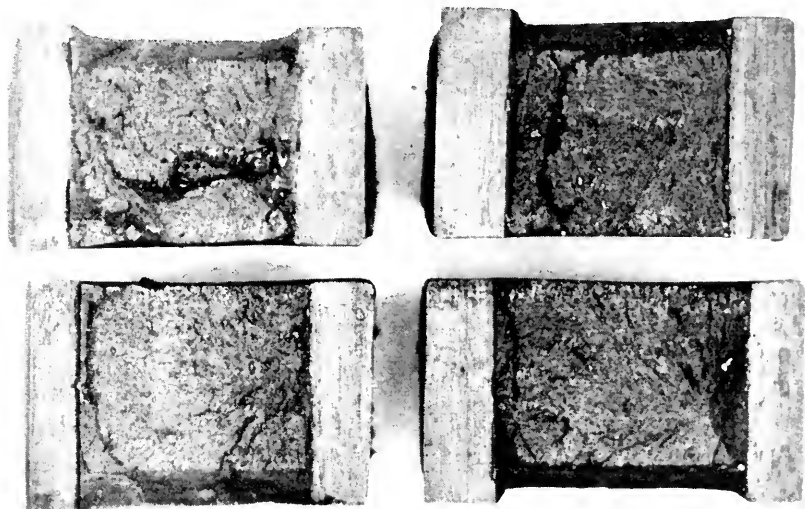
*Figure 8**Figure 9*

The side break test is somewhat new. It had been felt that the nick break specimen might not reveal defects that might exist on the side walls of the welding groove. To investigate this matter a defective weld was made in which there was a slag streak of somewhat minor proportions on the side wall. The weld was X-rayed and it was found that the defect continued throughout the length of the weld. Four nick break specimens and three side break specimens were removed. Two of the nick break specimens were broken in the customary manner with a quick, sharp blow, and the other two nick break specimens were broken by a slow bending. All of the nick break specimens broke directly through from notch to notch as shown in Figure 8. The side break specimens broke through the side wall defect as shown in Figure 9.

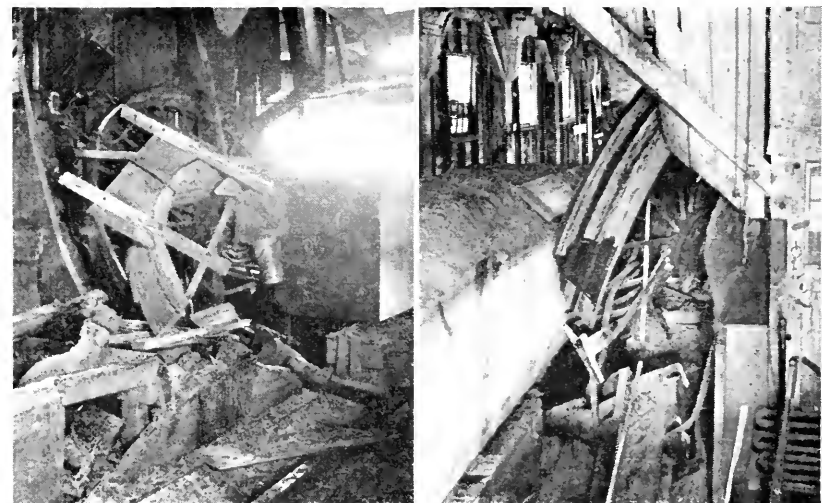
oman was killed
by the explosion
onal boiler in a
t in California.
eals part of the
eft—Three pic-
a Pennsylvania
water tank burst
otten after the
ighted. Damage
about \$7,000.

Upper Right—A hot water heater failure in a Pennsylvania business block injured a woman and resulted in property damage estimated at \$5,000. The blast tore loose the 750-gallon hot water tank shown in the photograph. **Lower Right** — A welded quill pipe steam radiator exploded, scalding an employe and damaging equipment, walls and show window of an Iowa shop. Windows were shattered in automobiles parked in the street in front of the store.

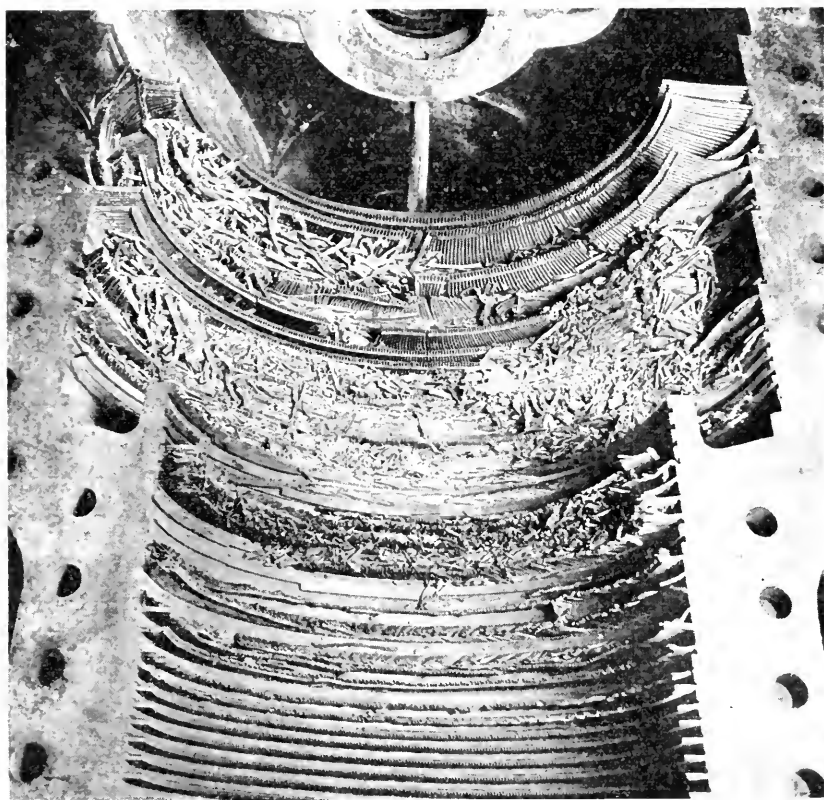
Figure 3—Casing of 1875 kva turbine after several blades broke out. The rotor was stripped of practically all of its blading.

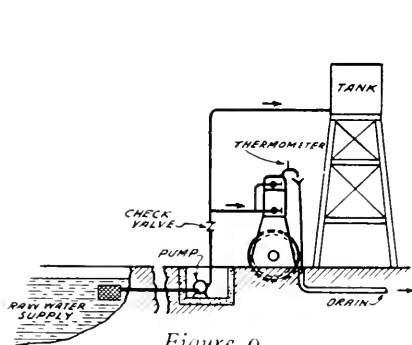
Figure 9.

seasons of the year, contain large quantities of suspended matter which are deposited in the cylinder jacket as a soft mud. There have been many piston seizures, excessive cylinder distortions and cracked heads directly caused by a water source becoming suddenly very muddy after a long spell of heavy rains. This hazard is present in connection with the continually wasting type of open system, as shown in Figures 9 and 14, as well as with the recirculating type of open system shown in Figure 11.

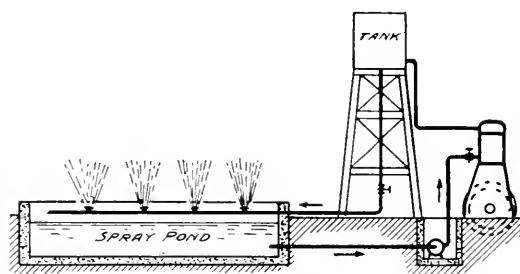
Figure 11.

Another serious trouble that has been experienced with the use of the recirculating type open system is the obstruction of the piping and water passages through the jackets by foreign material such as lint and dust from manufacturing processes. Such material drifts into spray ponds and into open receptacles under cooling towers.

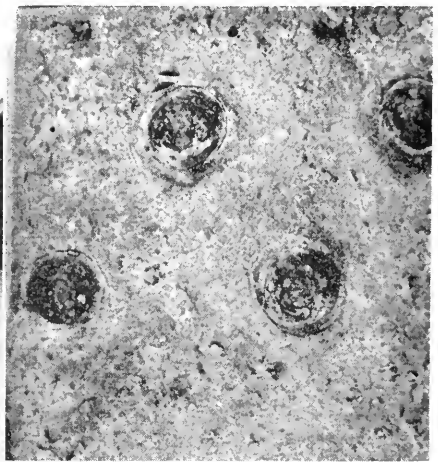
Figure 3

The vessel was destroyed by the explosion, its contents were badly damaged, asbestos was scattered throughout the large room, (120' by 165') and condensed steam saturated all the equipment there. Many panes of glass were broken and the metal sash supporting them was bent. Of the 22 men in the room at the time 20 escaped without injury. The other two received minor cuts and bruises.

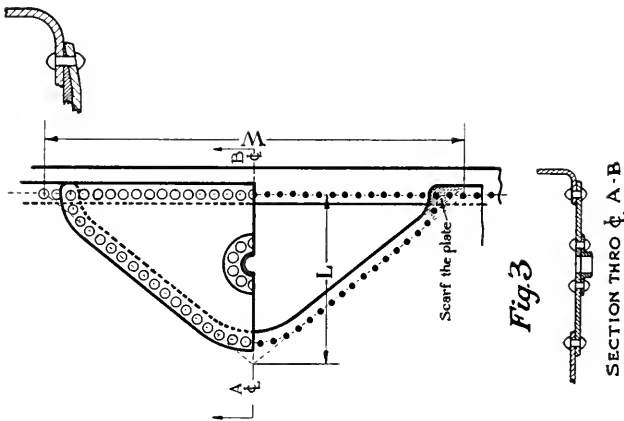
Sketch of patches
as viewed from
outside the boiler
or vessel.

Figure 3 illustrates a method of patching the rear course of a horizontal tubular boiler where the patch is to include the blowoff connection. It will be noted in this case that it is necessary to scarf the boiler shell plate where the patch, shell plate and head lap at each end of the patch.

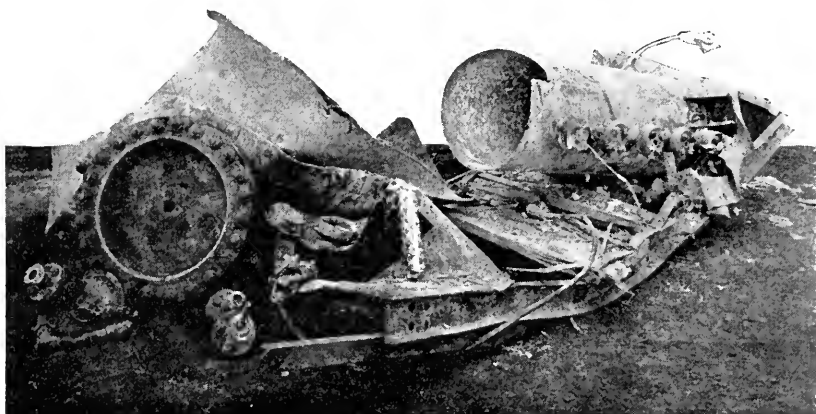
Figure 1. Parts of the destroyed vessel gathered together after the accident.

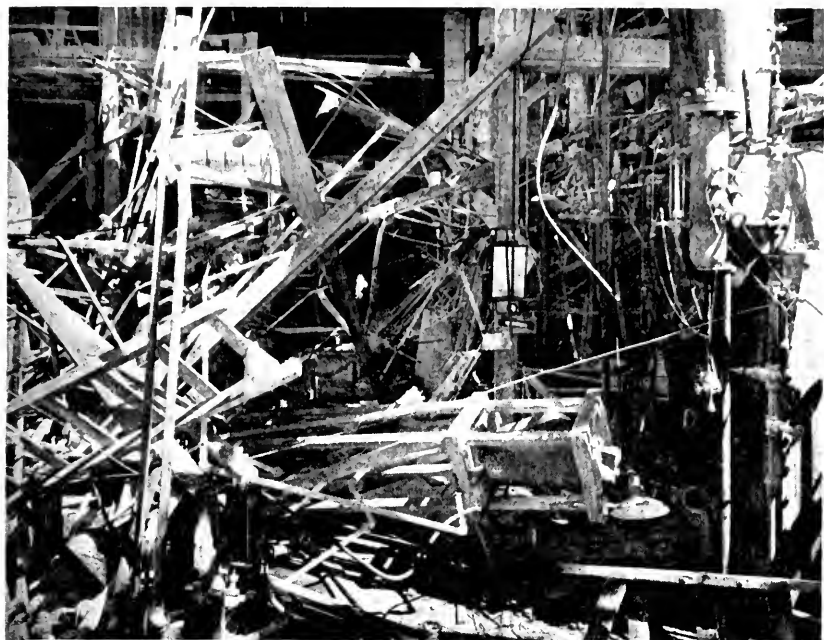
Figure 2. Wreckage caused by the explosion and the subsequent collapse of the building.

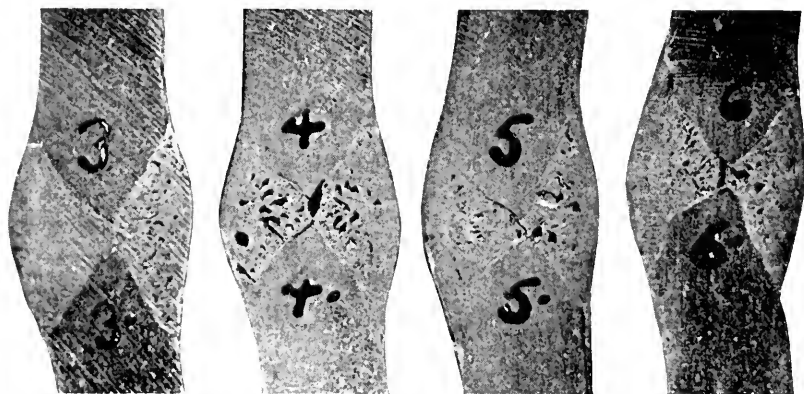
Figures 3-6. Etched specimens of welds from the vessel which failed, showing lack of fusion and general porosity in specimens 4, 5 and 6.

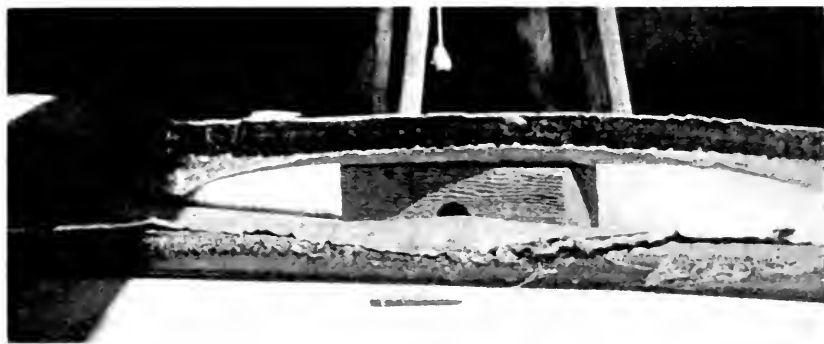
When the defective cable had been pulled and laid out on the floor, it was found that the lead was corroded through for about two-thirds of the length of the cable and could be stripped off without cutting. This condition is shown in Figure 1. There was no point on the cable

Figure 1—Cable attacked by corrosive caustics in seepage water.

indicating that injury had taken place during installation or afterward, except possibly at the lower end, which had rested on the edge of the duct. Apparently that was the point where current leakage had taken place and resulted in local heating.

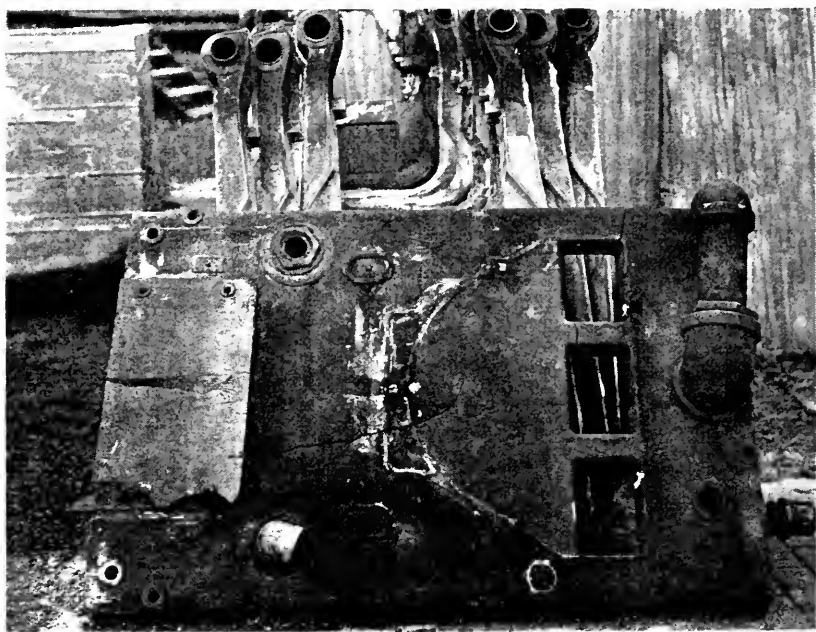
Figure 1. Cracks in a cast iron section—never a spectacular accident but the most frequent of all failures of heating boilers.

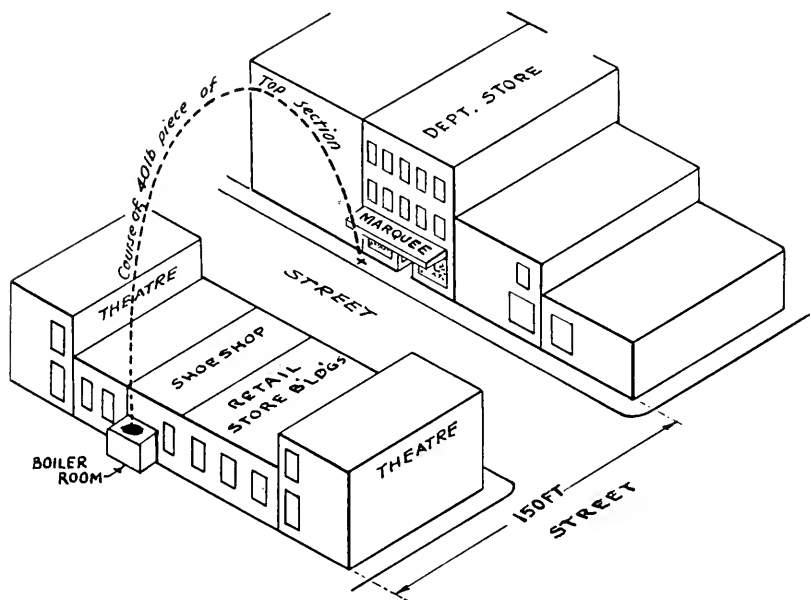
Figure 3. Course of travel of the top of a hot water heating boiler that exploded because of over-pressure.

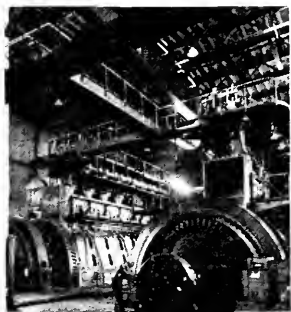
THE breaking in half of the rotor of a 3600 rpm, 1500 kva generator driven by a reaction type turbine at a Southern plant gives evidence that the generator end of turbines is not exempt from "explosions." When this accident occurred, one man, in attempting to

Generator rotor which exploded.

avoid injury, jumped from a window and broke his ankle, and another received minor injuries because of flying metal. A turbine erector, who tried to knock out the emergency trip by hand, reported that he found it was already out. Damage was estimated at \$20,000.

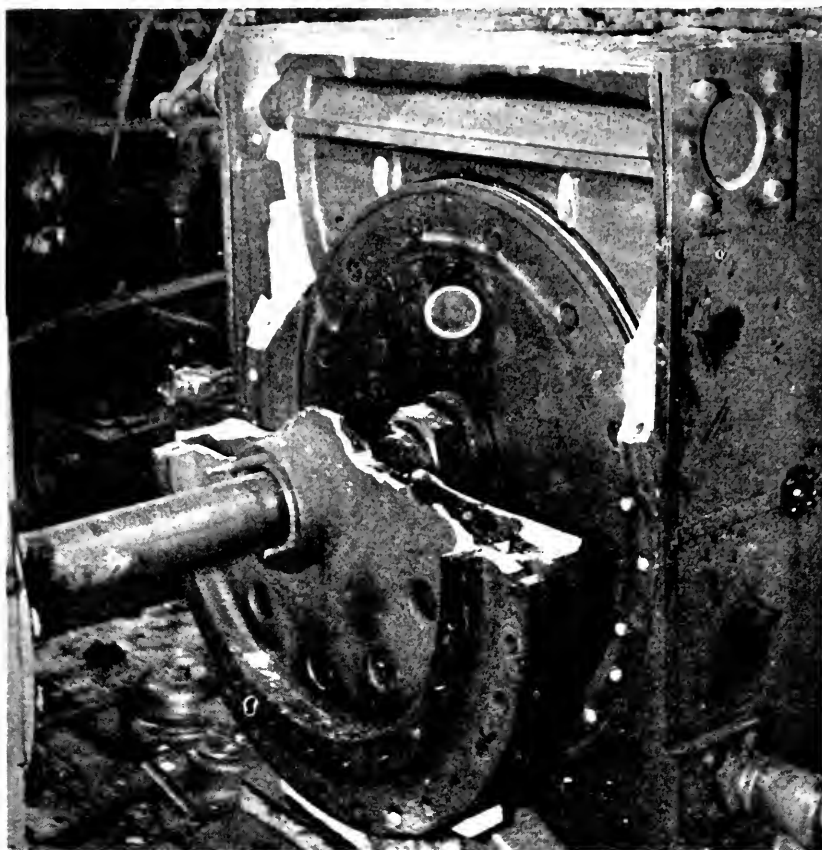
Figure 1—Cylinder wrecked because of connecting rod failure. The damage is typical of accidents from this cause.

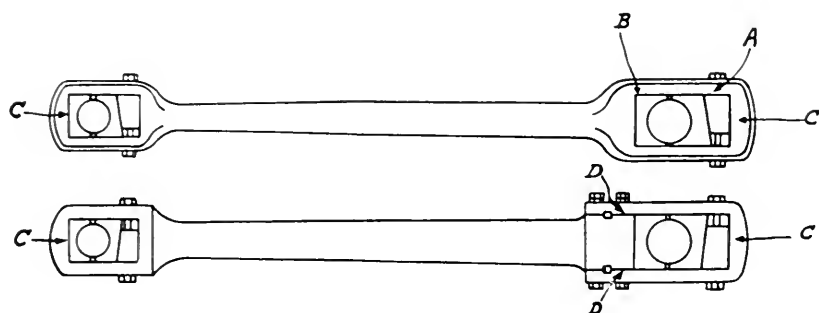
Cracks in the end members "C" are, as a rule, caused by sudden obstructions such as water in the cylinder. Weakness in these members usually occurs because the designer apparently assumed that the load was uniformly distributed over the entire length of the "beam." Actually, in view of the fact that the wedge may be considerably shorter than member "C," it is safer to regard the "beam" as having fixed ends and its load applied in the middle. In rods which are properly designed, "C" is made very heavy.

A steel mill recently was the scene of a serious accident because of a break at "B" at the crosshead end of the connecting rod of a large twin-tandem-compound steam engine. The left side of the engine was almost completely wrecked, as is indicated by Figures 1 and 4—an end of a low pressure cylinder and the connecting rod, respectively. The rod is an open-hearth steel forging with solid ends, is 15' 8" in length and weighs 4,900 lb. The low pressure cylinder is 56" in

Figure 2 (above)—Solid-end type of connecting rod. Figure 3 (below)—Open-end type of connecting rod for center crank engines.

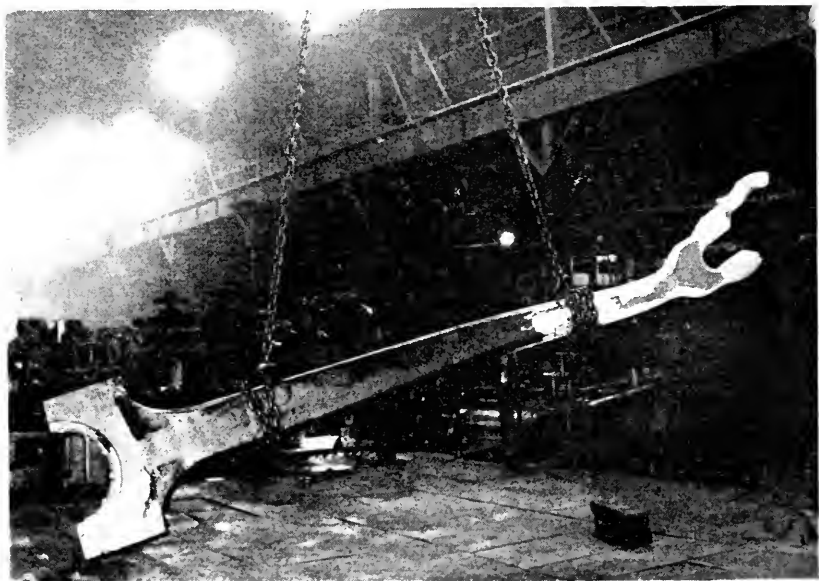
Figure 4—Typical break of the rod-end in a large Corliss engine.
